Silver Lake Sediment Cap Design
In-lake portion: no geotextile or armor stone

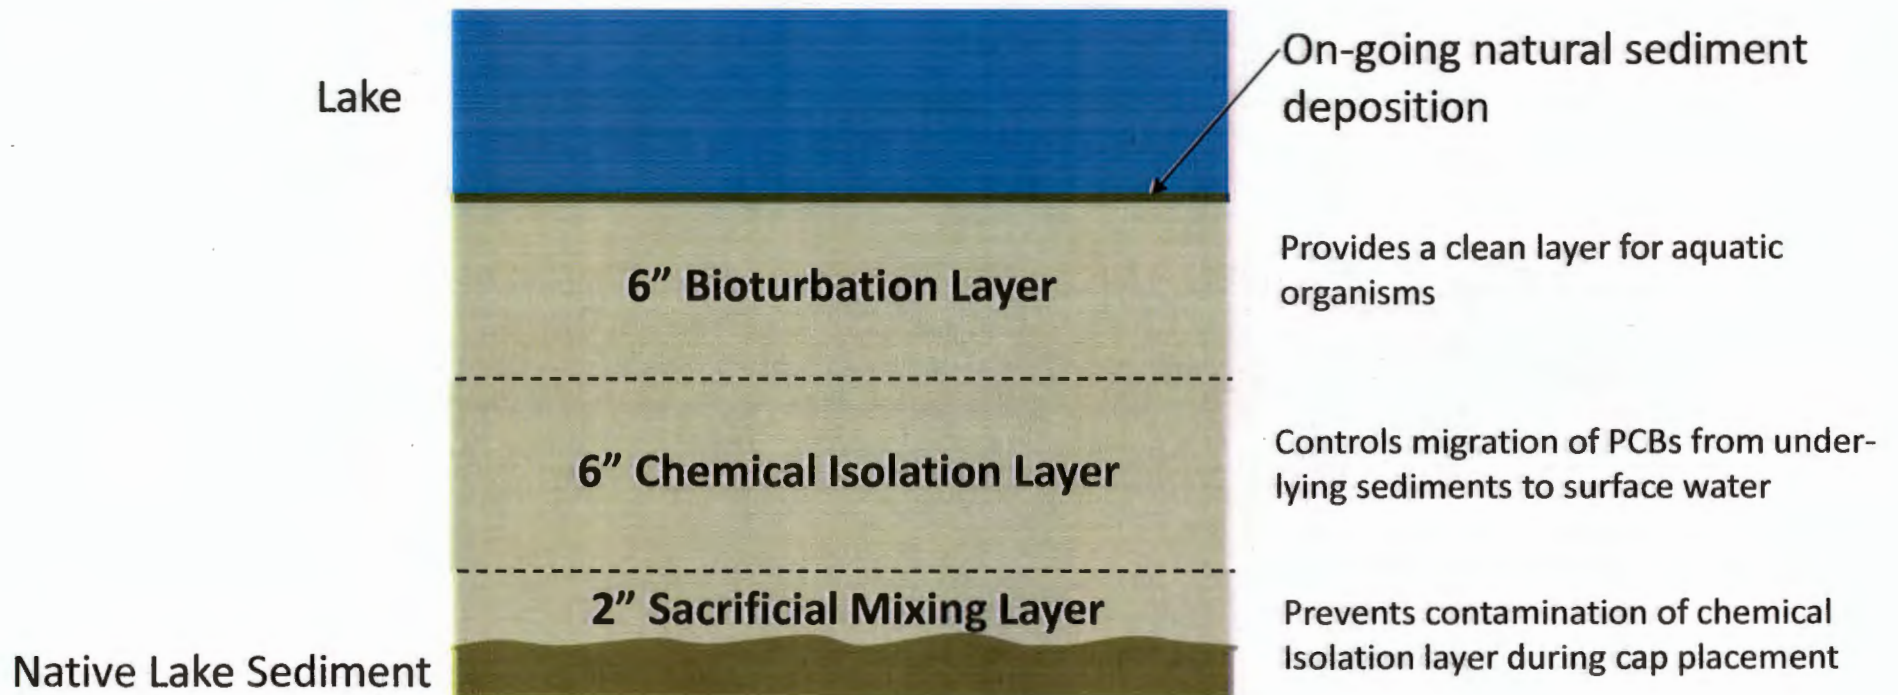
NOTE: cap performance std of 0.5% TOC measured in place

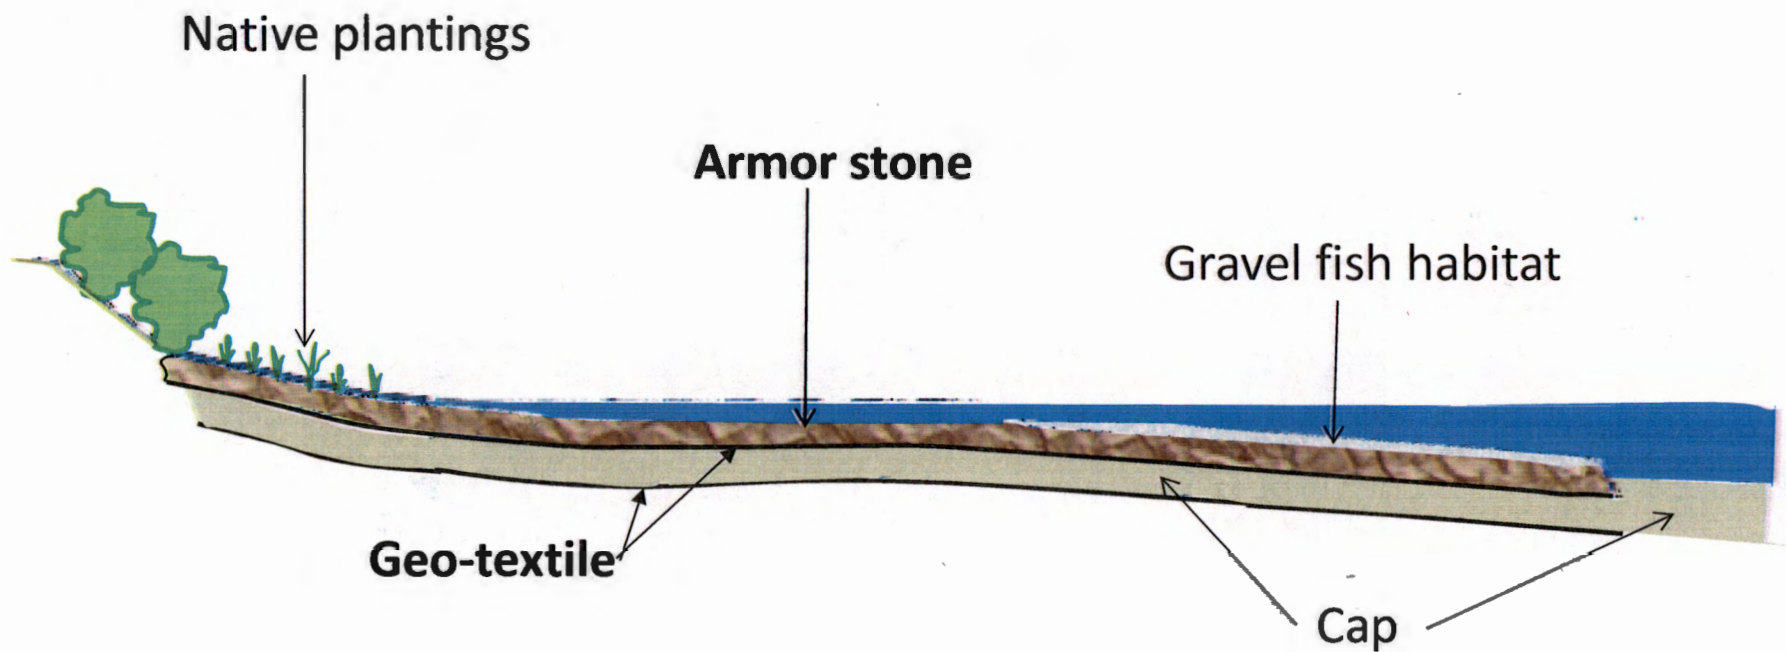
Near-shore cap design differs from in-lake design

**NOTE: RCM added as needed during construction along the shore only
when NAPL/sheens were observed**
